RESEARCHES AND EVALUATIONS
IN THE FIELD OF
ARCHITECTURE

USE OF DIGITAL TOOLS IN DAMAGE ASSESSMENT METHODS OF EARTHQUAKES IN TÜRKİYE

INVESTIGATION OF THE USE OF LOCAL MATERIALS IN HISTORICAL BUILDINGS: THE CASE OF AYVALIK

A RESEARCH ON THE USE OF ROBOTIC SYSTEMS IN CLEANING CURTAIN WALLS OF HIGH-RISE BUILDINGS

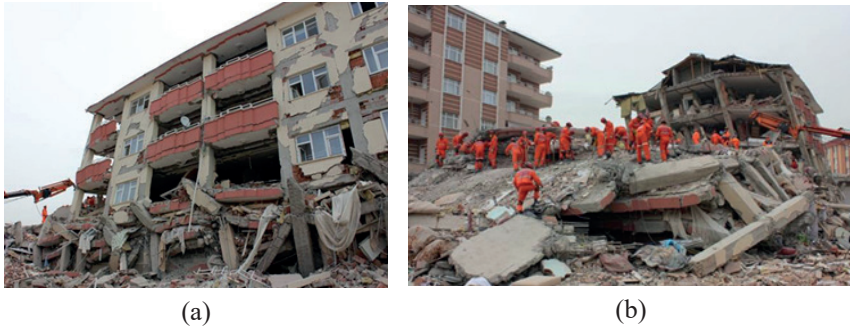
Figure 5. 2011 Van earthquakes; (a) soft storey irregularity, (b) inability of the building structure to withstand earthquake loads (Damcı et al., 2015)

forms and GPS-based applications, using mobile devices such as tablets and smartphones to assess damage. This method enabled data to be instantly transmitted to a central database and analyzed, thus significantly increasing the speed and accuracy of damage detection (Işık et al., 2018). Figure 5 shows the size of the earthquake.

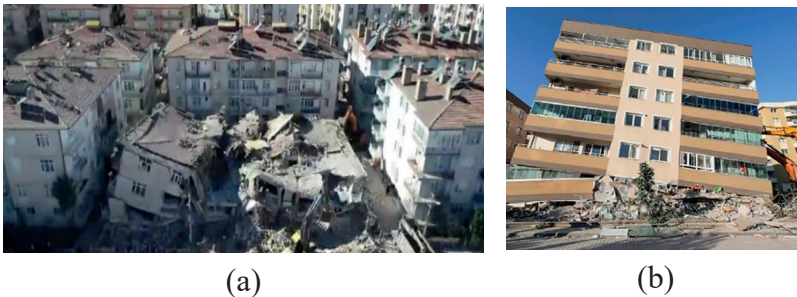
Figure 6. Earthquakes in 2020; (a) Elazığ earthquake (Dogan et al., 2021), (b) İzmir earthquake (Demirci et al., 2022)

During the Elazığ and İzmir earthquakes, mobile applications and social media platforms played an important role in damage assessment and disaster management processes. Citizens reported damage via mobile applications and this information was transmitted to central databases and analyzed. This method enabled teams in the field to quickly access information and organize response plans accordingly. Social media has been used as an effective communication tool for citizens to quickly communicate their situation and needs, which has helped disaster management teams respond more effectively (Ağralı et al., 2022). Figure 6 shows the effects of earthquakes on buildings.

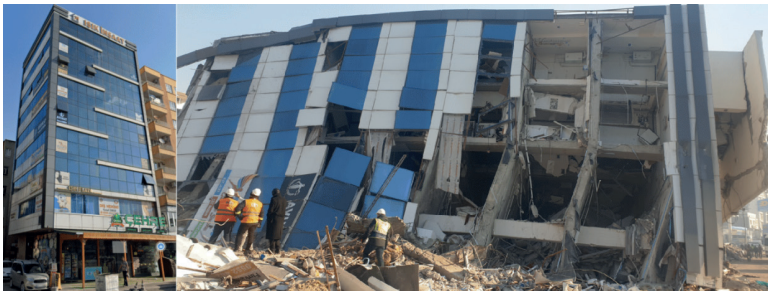
Figure 7. *Collapse of a building as a result of the 2023 Kahramanmaraş earthquakes (Mertol et al., 2023)*

In the 2023 Kahramanmaraş earthquakes, internet-based data collection platforms and mobile applications also became important components of damage assessment processes. Citizens reported damage through these platforms and this information was transmitted to central databases and analyzed. This method allowed field teams to collect damage data in a standard format and correlate it with GPS coordinates. In this way, it has become easier to geographically map and analyze the collected data. Additionally, these technologies have increased the speed and accuracy of data collection and sharing processes (Ayso et al., 2024). Figure 7 shows the magnitude of the earthquake.

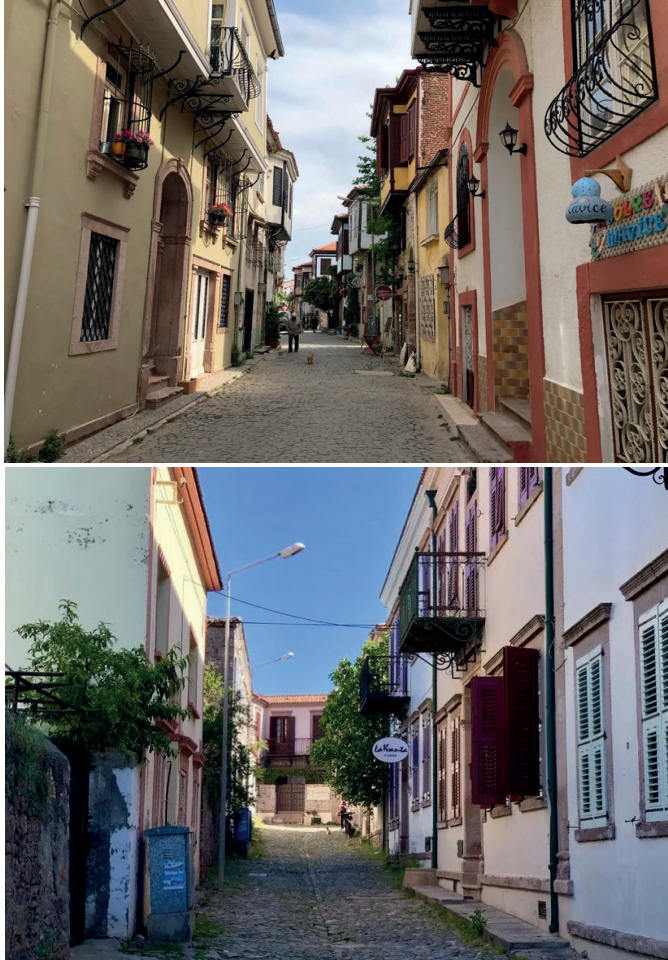
Figure 3: Ayvalık traditional houses

Traditional houses are generally built in adjoining order, with one or two storeys above ground, using masonry construction system and stone material. The use of backyard-courtyard is common in houses with entrances directly from the street. Houses located on corner plots can open to the street on both sides. There are types with and without overhangs in the façade layout (Figure 3). When the façade layout is examined in detail, it can be said that the fact that the first users of the houses were non-Muslims or Levantines has an effect on the façade layout, design and

ornamentation programme. It is understood that the plans of the residential buildings were designed according to the needs and lifestyle. Based on the fact that the common architectural language can be read throughout the city, it is possible to say that there is a regular construction in the settlement.

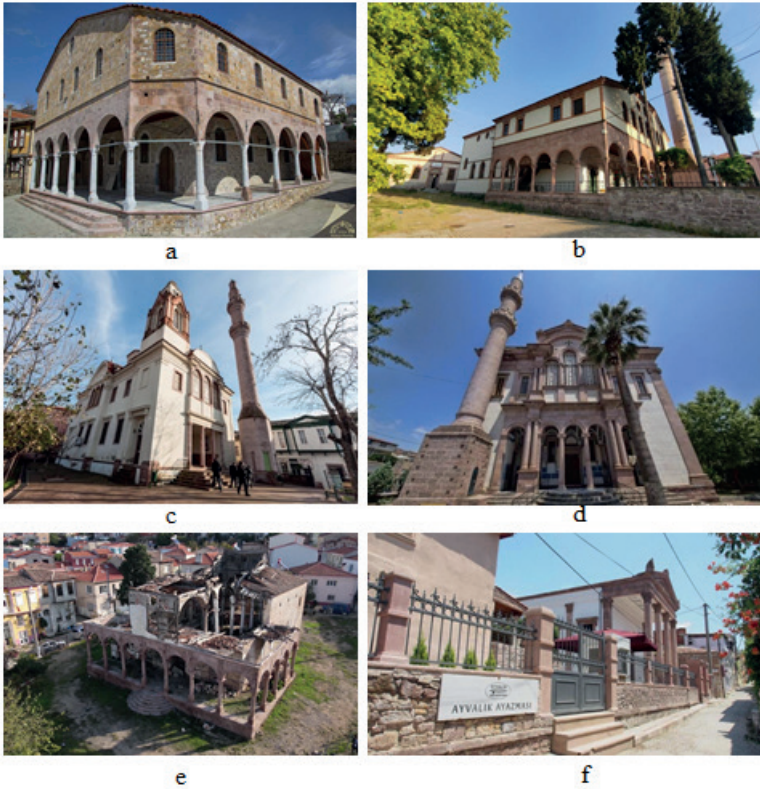
Figure 4: (a) Taxiarchis Church - (b) Kato Panayia Church (Hayrettin Pasha Mosque) - (c) Hagios Goannes Church (Saatli Mosque) - (d) Hagios Georgios Church (Çınarlı Mosque) - (e) Hagia Triada Church - (f) Faneromeni (Ayazma) Church

The monumental religious buildings of the city are the churches built by non-Muslims, the users of the city, after the 18th century in locations dominating the silhouette of the city and playing an active role in the formation of the historical texture. Some of the churches, monasteries and

chapels that have survived to the present day are as follows. Taxiarchis Church, Kato Panayia Church (Hayrettin Pasha Mosque), Hagios Goannes Church (Clock Mosque), Hagios Georgios Church (Çınarlı Mosque), Hagia Triada Church, Faneromeni (Ayazma) Church and Portaitissa Church (Figure 4). These buildings in Ayvalık City centre. These monumental structures, which exhibit the architectural features of the neo-classical style as a reflection of the art environment of the 18th and 19th centuries, are considered as the continuation of the Byzantine Churches, but they also create their own architectural style by being influenced by the local architecture (Güney ve Uçar, 2010). It is observed that most of these buildings were used for functions different from their original functions after the exchange and some of them were left empty. The Church of Taxiarchis is currently functioned as a memorial museum. The inscription at the entrance of the church, which is thought to have 3 different construction periods, states that the construction was completed in 1844. The church has a simple mass and plan organisation and draws attention with its spatial character and Greek Period decorations decorating the interior. (Uçar, 2013). Kato Panayia Church, Hagios Goannes Church and Hagios Georgios Church function as mosques. Today, Faneromeni (Ayazma) Church is also exhibited as a museum with its original plan scheme. Hagia Triada Church is in ruins and restoration works have been started. In addition to the Greek-Orthodox churches, the Hamidiye Mosque, the only mosque built in Ayvalık during the Ottoman period, was built by Sultan Abdülhamit for the Muslims living in Ayvalık and is a special building that attracts attention with its different architecture.

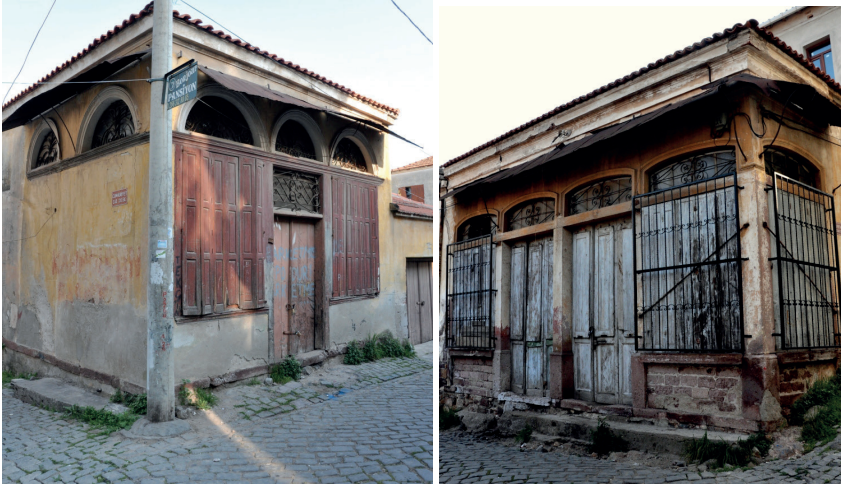
Figure 5: *Typical non-used shop examples (Akin Akbüber, 2020).*

In 19th century Ayvalık, an important commercial and educational centre, Greeks built olive oil factories, soap factories, schools, shops and warehouses reflecting their social, economic and cultural level. In addition, flour mills and tanneries built on the seafront are among the buildings constructed for commercial purposes. The shops, which constitute the most crowded building group in the urban fabric after the residential architecture, have made ayvalık one of the bustling harbour settlements with its industrial and commercial activities. these buildings allow the evaluation of the trade potential and the architectural identity of the city to be read (Akın Akbüber, 2020). The fact that the shops were taken under protection together with the houses has enabled them to survive until today. However, most of these buildings were abandoned because they could not meet the comfort demands of the new users. Restoration works have recently started for many of the abandoned shops (Figure 5).

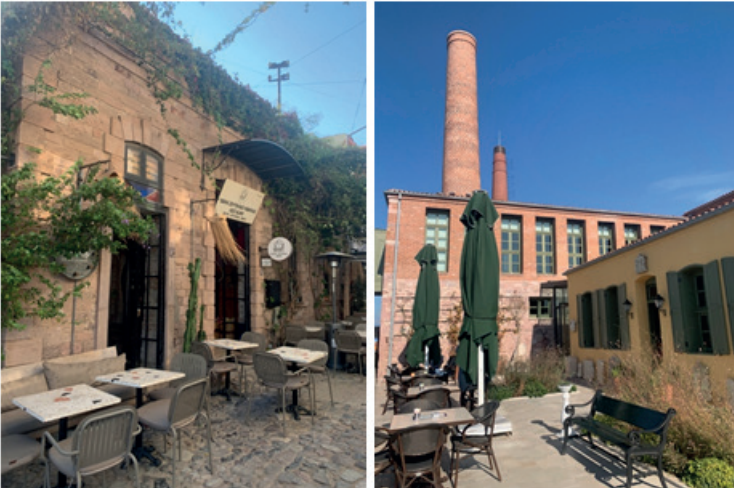
Figure 6: *Olive oil production facilities of different scales*

The most intensive trade in the region during the period was olive oil and soap production. In this context, the previously small enterprises were replaced by factories where industrial production would be carried out to a large extent with the introduction of steam power. The machines operated by steam boilers increased the production capacity and accelerated imports. At the same time, locally small enterprises continued to produce. Ayvalık's commercial building stock, which incorporates a wide range of commercial buildings ranging from undivided, square or rectangular shops to olive oil factories, which are the smallest unit of the bazaar texture, is considered as industrial heritage (Fig 6)

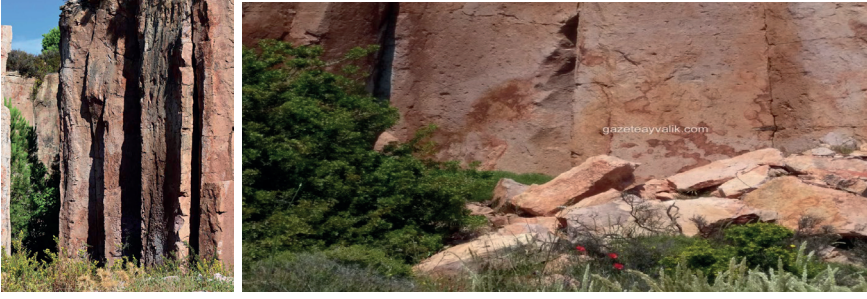
Figure 8: *Ignimbrite stone-Sarımsak Taşı* (Özmürüt, 2008; Efe ve İnan, 2023)

The most frequently used material in Ayvalık historical buildings is ‘Sarımsak Taşı’. The stone is pinkish in colour and of volcanic origin (Figure 8)(Altunkaynak, 1997). Due to its durability, easy workability, long life span and colour (rose dry, pink), it was used as the most important local building material source in the region in the past. The stone is found in the pinkish-coloured, abundantly fiamme-structured and pumice-rich Ayvalık ignimbrites of Lower Miocene age. It is extracted from quarries located in Badavut, south of the Salt Lake, at the southwestern end of the Sarımsaklı Peninsula. İgnimbrite tuffs are dense in the quarry and its surroundings (Akyürek, 1978).

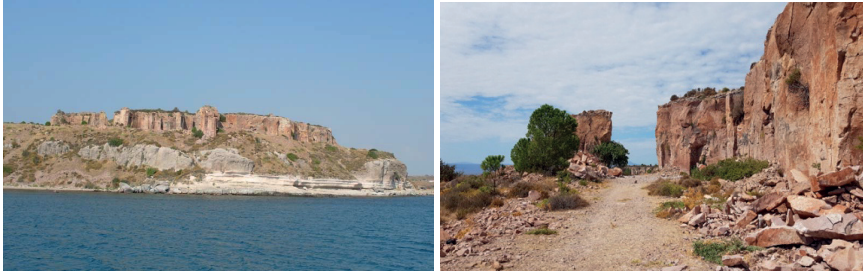
Figure 9: *Badavut stone quarry* (Özmürüt, 2008; Efe ve İnan, 2023)

Sarımsak taşı, was used as a building material in almost every period of the traditional and monumental architecture of Ayvalık and its neighbourhood. Badavut Quarry (Figure 9), which is the most used local material source of the region, was declared a Grade I Natural Protected Area in 1989, preventing the supply of stone from here, and in 1995 it was taken under protection by being included within the borders of Ayvalık Nature Park. The quarrying of stone from the quarry is now subject to the special permission of the General Directorate of Nature Conservation and National Parks.

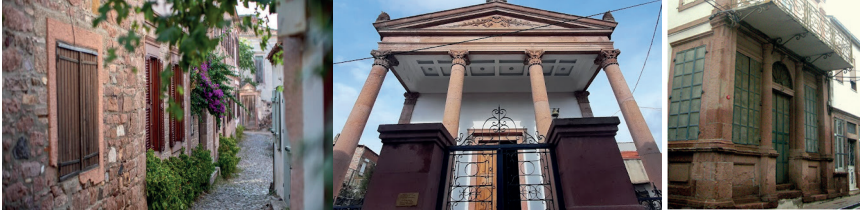
Figure 10: *Use of sarımsak taşı in load-bearing elements*

In this part of the study, the use of sarımsak taşı, which is a local material source in traditional houses, monumental structures and commercial buildings in Ayvalık settlement, was examined. The use of volcanic garlic stone, called ignimbrite, as a carrier in walls, columns, lintels and architraves is common in structures (Figure 10).

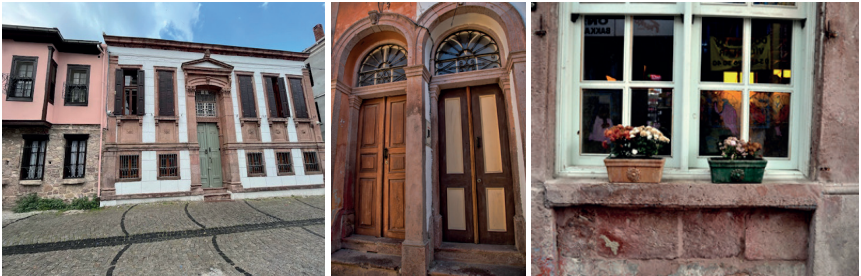
Figure 11: *Using sarımsak taşı on house doors and windows*

When the facade elements are examined; it is seen that this stone is used in door-window jambs, pilasters as facade decoration, floor and eaves molding. (Figure 11). In some of the buildings where projections or balconies are used in the facade organization, stone is also used in the buttresses carrying the projection.¹ The use of sarımsak taşı has also been detected in the bell towers of religious buildings and in the minarets added to mosques converted from churches.

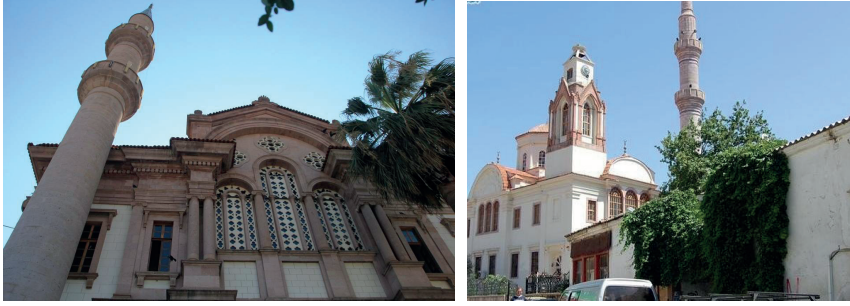
Figure 12: *Using sarımsak taşı on minarets (Çınarlı Mosque-Saatli Mosque)*

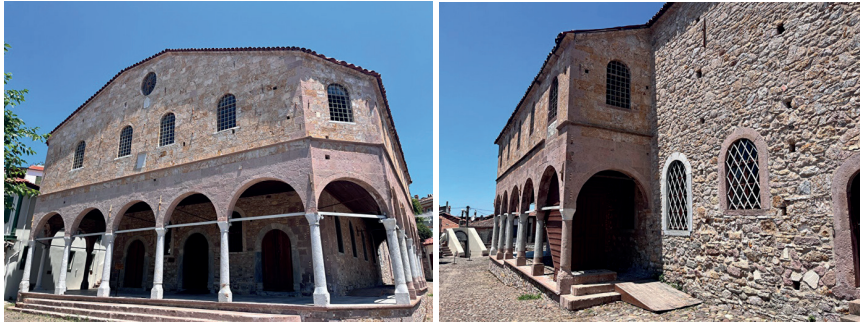
Figure 13: *Another local stone used in the region is yellowish andesite (Taxiarchis Church)*

Ticaret Commercial buildings are no different from residential buildings and monumental buildings. While the shops, which are smaller in scale than other buildings, use stone as a building material in the entire construction process, it was determined that bricks were used together with stone in the construction of structures such as olive oil factories, soap houses, etc., which are industrial heritage. Garlic stone was used in the stairs and flooring of almost every historical building in Ayvalık. It is also seen that garlic stone and yellowish colored andesite stone quarried from the region is used in the wall construction of Ayvalık historical buildings (Figure 13).

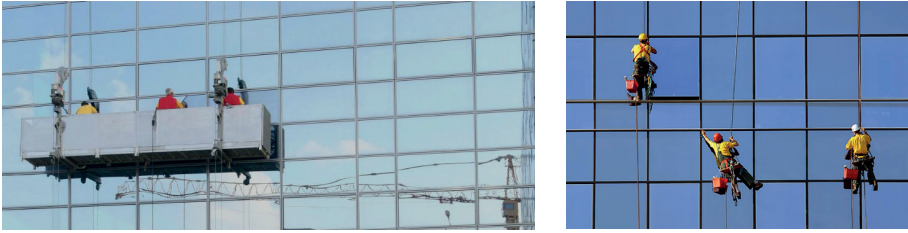
Figure 1. *Cleaning of high-rise building façades with traditional methods (URL-1; URL-2)*

Today, façade cleaning of high-rise buildings is generally based on crane, basket or climber cleaning techniques under the supervision of human operators (Figure 1). Since these methods depend on manpower, they cause socioeconomic losses due to work accidents. In Germany, the USA, France, and other countries, various façade robots have been developed for building façade maintenance and cleaning (Lee et al., 2018). Robotic systems can make it possible to clean the façades of high-rise buildings without risking the life safety of employees. In addition, it can increase technological level and productivity (Zhang et al., 2007).

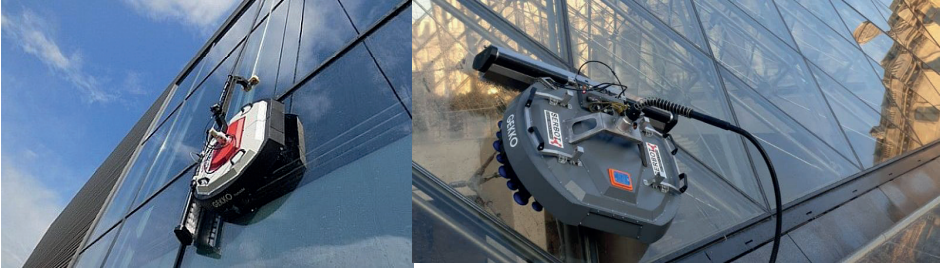
Figure 7. *GEKKO façade cleaning robot (URL-7; URL-8)*

- It offers a suitable system for cleaning hard-to-reach façade surfaces.
- It provides a faster solution compared to manual cleaning.
- Cleaning can be done without the need for extra personnel.
- It offers the opportunity to work automatically. Only the person using the robot needs to direct it.

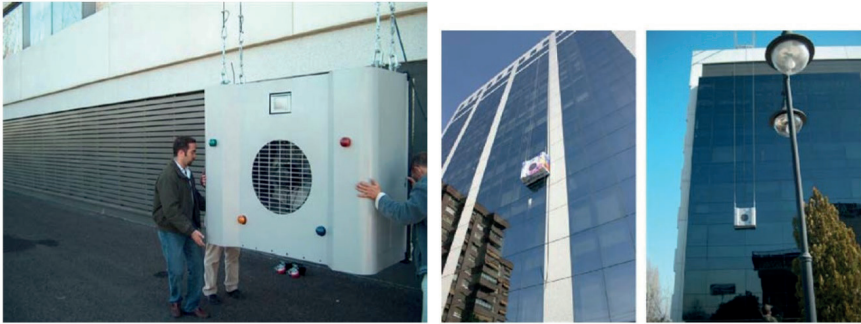
Figure 8. *Tito 500 façade cleaning robot (Akinfiev et al., 2009)*

Tito 500, the façade cleaning robot developed by RATIOFOREM, is used with a crane that can be mounted on a high-rise building to keep it in a vertical position (Figure 8). This crane can move around the outer surface of the building roof. This method is used when the robots to be used in cleaning operations are bulky and thus allows increasing cleaning efficiency. The wheel mechanism inside the robot acts as a damper at one point. The robot performs the cleaning process by moving up and down on the building façade along the vertical wires (Akinfiev et al., 2009).

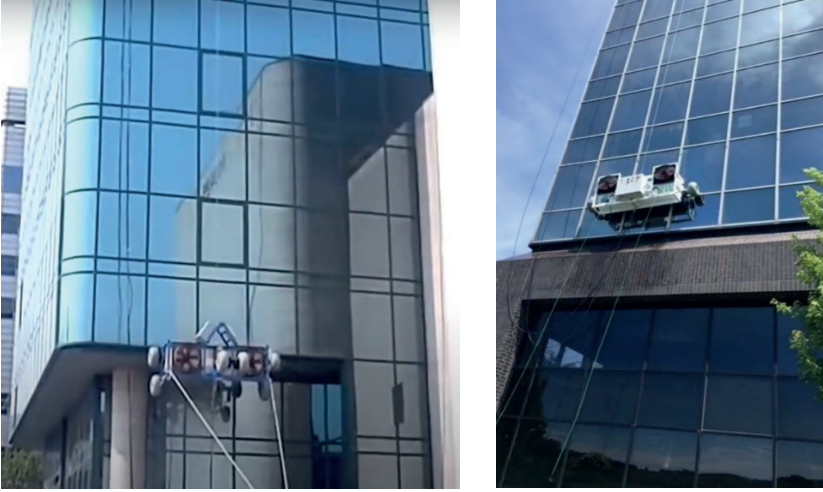
Figure 9. *Sky Pro façade cleaning robot (URL-9)*

It is a façade cleaning robot that uses a rope mechanism to move on the façade surface and includes a brush system for the cleaning process (Figure 9). The robot, which can clean up to 60 times, has removable rotating wheels at the bottom for easy transportation (URL-9).

The robot, which performs the cleaning function, can move vertically during the façade cleaning process with the help of wires. As a cleaning tool, it has a rotary brush type system.
